Archaeological Site and Reservoir Shoreline Stabilization Using Wetland Plants and Bioengineering, Rice Reservoir, Wisconsin

by Cathy J. Wendt and Hollis H. Allen

PURPOSE. This technical note describes a case study in which wetland plants and bioengineering treatments were used to protect an archeological site on an eroded reservoir shoreline and to stabilize the shoreline from further erosion. The site is called the Robinson Site and is located on Rice Reservoir in northern Wisconsin, about 26 km (16 miles) southeast of Rhinelander.

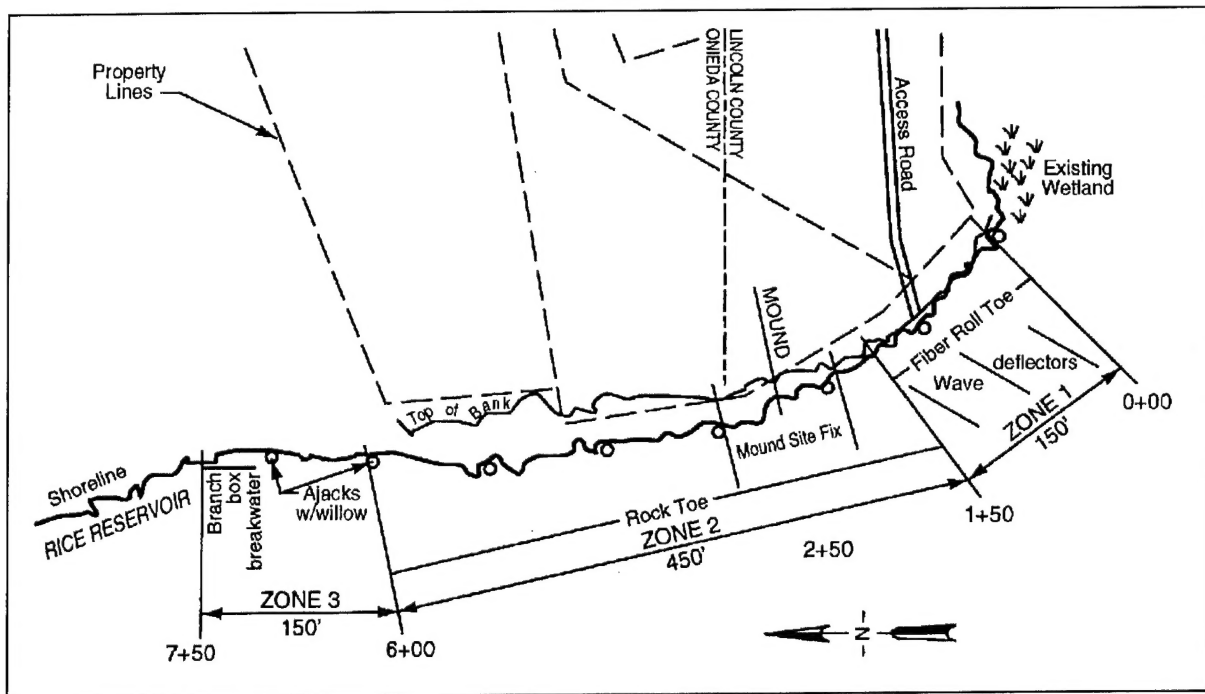
Figure 2. Zones of eroded shoreline and installed measures

The project was divided into three zones defined by the severity of erosion and associated measures used to protect the bank (Figure 2). Zone 2 was the most severely eroded and contained a partially exposed burial mound. Portions of each zone were included in a workshop held in April 1999. The purpose of the workshop was to learn bioengineering techniques and share expertise with State and local agencies and with private entities. A description of each zone prior to construction follows.

- **Zone 1** - The southern 45-m (150-ft) section varied in bank height from 0 to 4 m (0 to 12 ft). A natural wetland exists around the point at the south end. This zone had vertical, lower banks that required less protection.

- **Zone 2** - The middle 14-m (450- ft) section was the most severely eroded. Bank heights varied from 4 m to more than 9 m (12 to 30 ft) with an average slope of 1.5(h):1(v). This zone required installation of a hard toe and stabilization of the face of the bank.

- **Zone 3** - The northern 45-m (150-ft) section had the least amount of active erosion. The face of the bank in this area was fully vegetated with red and white pine, white birch, oak, aspen, shrubs, and herbaceous plants. Bank height varied from 0 to 6 m (0 to 20 ft) and the only erosion evident was an undercut lip at the toe of the bank. This zone required methods where no disturbance of the bank would occur. Protection was added at the toe to attenuate wave action that threatened the semi-stable area.

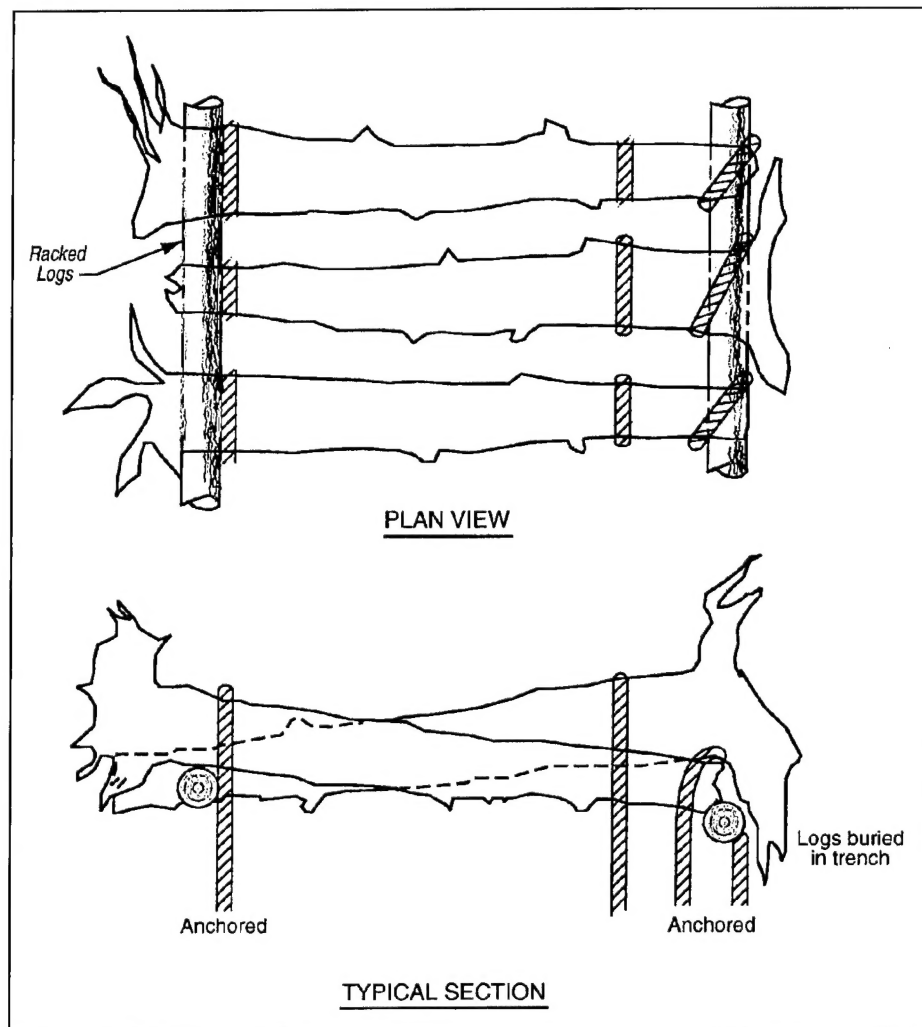
Figure 4. Anchored log wave deflector

Zone 1 Wave Deflector Performance. The wave deflectors failed within 5 months of installation. The precise cause of the failure was not documented or observed, but it appears that at a partial drawdown level, the wave action undermined the bottom crosspieces. When the water level again rose, it apparently floated the loosened crosspieces away, allowing the large trees they supported to buoy up and down with the waves, thereby loosening the anchoring system. The wave deflectors were removed entirely after the anchoring system failed.

Wave Deflector Installation. Three to four large trees were stacked with alternating butt ends together (Figure 4) at approximately 30 deg perpendicular to the shoreline. The trees were

placed on top of two pieces of 25- to 30-cm- (10- to 12-in.-) diameter red pine partially buried in the reservoir bottom and lying perpendicular to the trees. The trees were cabled in place using Duckbill® anchors. The wave deflectors were placed to block waves from northerly and northwesterly winds. The Duckbill® anchors were driven into the reservoir bottom, leaving only the portion of the cable connecting the trees exposed.

- Wave deflectors must be installed differently in a reservoir with fluctuating water levels. Possibly if the crosspieces were eliminated from the design, the larger trees could be anchored more securely.
- Fiber rolls can be easily vegetated using willow cuttings. There does not appear to be any advantage to using rooted stock instead of dormant, unrooted cuttings. Inserting herbaceous plants into the fiber roll is difficult and was not very successful at this particular site.

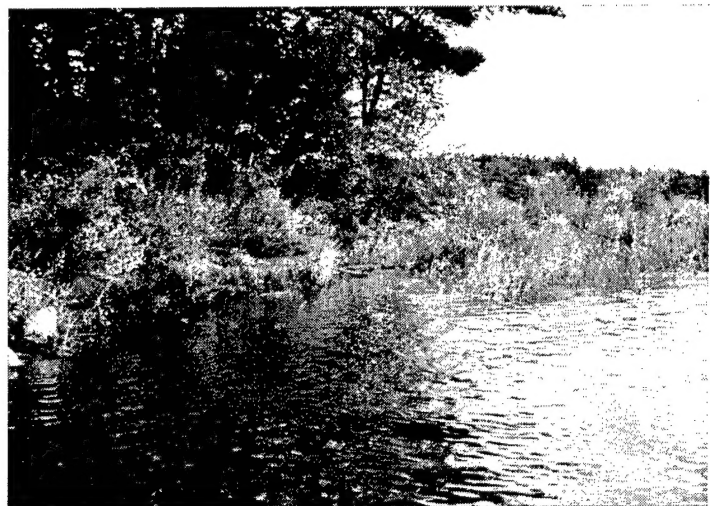
Figure 9. Zone 1, July 7, 2000

In Zone 1, the fiber rolls have remained intact (Figure 9) with an added benefit of providing wildlife habitat. Burrowing animals, primarily rabbits, excavated and inhabited small

openings behind the fiber rolls. These openings do not seem to be compromising the integrity of the structure. The rabbits browsed much of the willow over winter that had been planted as cuttings behind and between the fiber rolls. Despite the browsing, the willow resprouted. Of the 20 rooted willows (USFS stock) that were planted, 10 have survived.

Juncus spp. and *Scirpus* spp. planted directly in the fiber rolls suffered high mortality with only 10 percent of the original plants remaining on August 11. However, the fiber rolls are becoming vegetated by native volunteer species.

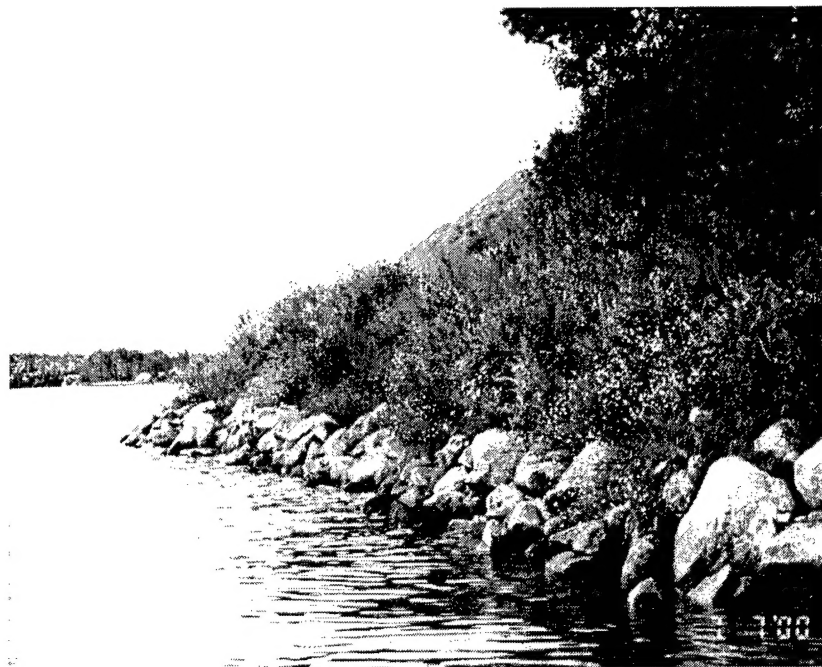
Figure 10. Zone 2, July 7, 2000

Zone 2 Rock Toe Performance. The rock toe has performed as expected for the majority of the zone (Figure 10). Soon after completion, however, the reservoir level rose and a void was created behind the large rocks, causing 1.5 lin m (5 lin ft) of soil lifts to collapse. Filling this area with small rock repaired the void and no further erosion has occurred in this area.

Additional smaller areas (1-2 m³ or 11-22 ft² each) have also washed out, but no major problems seem to have been created by these voids. As a preventative measure, these new voids could be filled, but the voids seem to have limited themselves and our intent is to monitor them to see if they will be "self-healing." All of the voids are located away from the mound. It appears that the reduced level of armoring in the fix away from the mound may be contributing to these minor failures. No failures have occurred in the mound fix area.

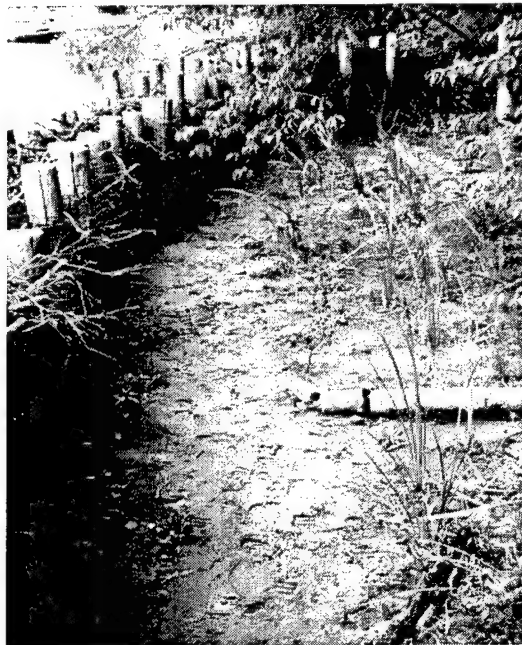
Figure 14. Area behind branchbox breakwater

Zone 3 Branchbox Performance. The branchbox breakwater is providing limited habitat for emergent plants (Figure 14). The habitat is limited because Wisconsin laws prohibit most structures from being more than a few feet away from the shore. The Wisconsin Department of Natural Resources did, however, allow this structure for demonstration purposes, but only allowed it to extend 4.5 m (15 ft) from the shore. This is still short of the more typical placements of 10 m (33 ft) or more.

It appears that the area between the branchbox and shore may have suffered from either or both of two effects created by the branchbox's proximity to the bank. First, the protected area is shaded by existing trees on the steep bank for half of the day, then is shaded by the branchbox breakwater for much of the remainder of the day. This lack of sunlight may be responsible for an observed 0.76-m- (2-1/2-ft-) wide area directly behind the branchbox that is unvegetated (Figure 14). Second, sand has deposited behind the branchbox to a height approximately 6 in. higher than directly in front of the branchbox. This sand appeared to be enough to cover small plants as they began to grow. Between this 0.76-m- (2-1/2-ft-) wide void and the original bank, however, there is vegetation. Quadrats were used twice to assess the vegetation of the entire area behind the branchbox breakwater, once on May 17, 2000 and again on July 7, 2000. The entire area was covered with 28 quadrats or partial quadrats. Numbers of *Juncus effusus*, *Scirpus spp.*,

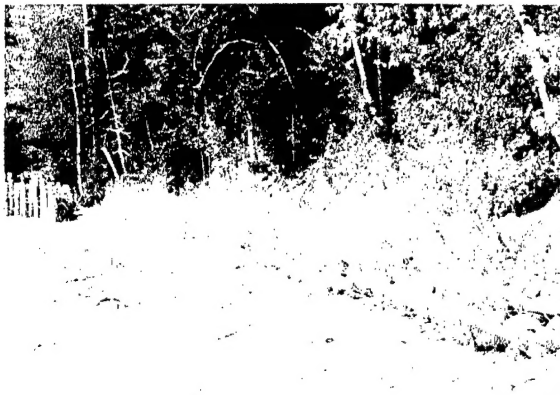
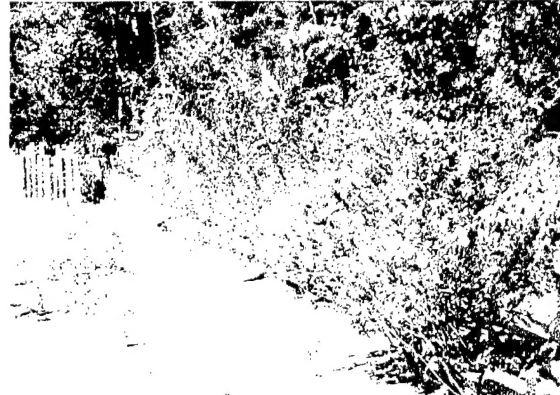
Zone 3 A-Jacks® Performance. Due to the heavy vegetation, the A-Jacks® are barely visible from the water. Although the total stem count has decreased (359 stems on July 7, 2000 down from 391 stems on May 16, 2000), the percent area covered is increasing based on visual comparison of photos (Figures 16 and 17). The stem count may have decreased for several possible reasons. First, the water level of the reservoir was within 3 ft of full by the middle of April, which provided the plants with adequate moisture producing the initial surge of growth indicated by the high stem count for May. Second, from the end of June through early August the water level was within 1 ft of full and some of the individuals may have succumbed to drowning and/or wave action causing abrasion from the A-Jacks®, lowering the overall stem count. Third, competition for light and nutrients between individual plants may have been a source of mortality.
